# PUMPING NEW LIFE INTO A FAILED PUMP

A refurbishment with Graphalloy extends the life of a refinery centrifugal pump

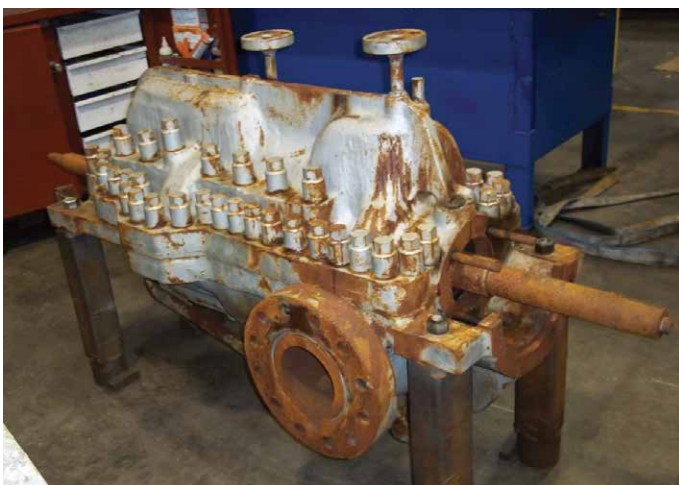
Figure 1

were also taken off but had not been shipped with the pump. The unprotected shaft protruding out of the pump case was heavily rusted as were the insides of the bearing housings.

Pump as it arrived at the C&K repair facility from the refinery. Note the severely rusted shaft protruding from both sides.

In the case of this refinery centrifugal pump, some parts needed to be reverse engineered. The rusted shaft was reclaimed using a High Velocity Oxygen Fuel (HVOF) thermal spray process to apply tungsten carbide, which was then ground and finally super finished to 8 rms (8 micro-inch) smoothness. The face of the stuffing box had been skim cut so many times that the stuffing box was too short for the mechanical seals. Adjustments needed to be made there.

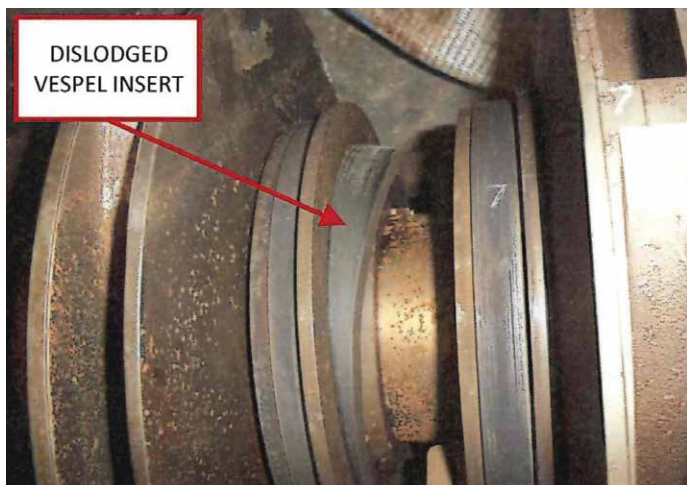
Figure 2

Dislodged Vespel insert on sixth-stage impeller.

During disassembly, he noted that the sixth-stage impeller hub case ring had a partially dislodged fluoropolymer composite insert (see figure 2). All other case wear rings, the first/second stage, balance stage and center stage also had composite inserts. Inspection of the impellers showed the impeller hubs had wear rings installed. However, the impeller eyes did not have wear rings installed and had been machined to a very thin condition to allow the use of composite inserts in this location.

Marrical says that the overheating of the Vespel had two sources: the high temperature of the hydrocarbons being pumped and the tight fit of the impellers on the shaft. A dimensional inspection of the impellers showed the impeller bores to have a fairly heavy interference with the mating shaft diameters. This heavy fit is not necessary for impeller retention on

This heating process during installation is probably what caused the stage 6 fluoropolymer composite insert to initially deform, and later move out of position when exposed to hot pressurized fluid while in operation. During inspection, therefore, it was impossible to determine the running clearances at the impeller eyes, hubs and balance stage pieces due to damage to the Vespel inserts from heating while disassembling the rotor.

In order to put the pump back into action and eliminate future concerns about overheating, (C&K) decided to use Graphalloy inserts by Graphite Metallizing Corporation. Graphalloy is a graphite/metal alloy which is used as a self-lubricating bearing material. It is non-galling, corrosion resistant, dimensionally stable and can operate at temperatures from cryogenic to higher than 1000 degrees Fahrenheit (537.78 degrees Celsius) depending on the grade of product selected.

For this application, C&K chose Graphalloy grade GM111.3, a nickel impregnated material that will withstand temperatures of up to 750 degrees Fahrenheit (398.89 degrees Celsius). Since C&K has a comprehensive ISO 9001 manufacturing facility, the only actions done outside were re-babbiting of some bearings. In addition, the company purchased a thrust bearing from Kingsbury.

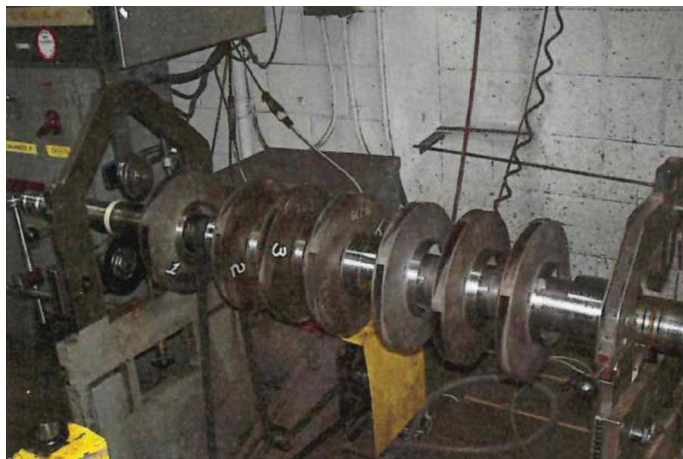
Figure 3

Rotor during balancing process.

After machining, welding, grinding, skim cutting, sandblasting, spraying, and finishing, the pump was ready for reassembly, testing, balancing (see figure 3) and shipping back to the tropics sporting a fresh coat of blue paint (See figure 4). ■

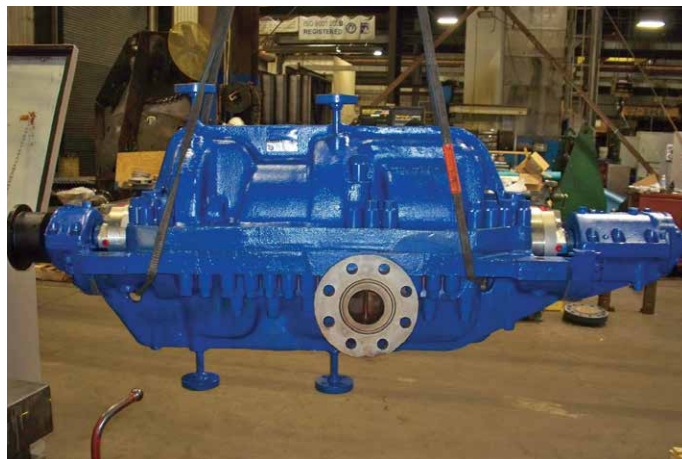
Figure 4

Repaired pump ready for shipment.
