General processing

Cooperation helps to eliminate pump failures

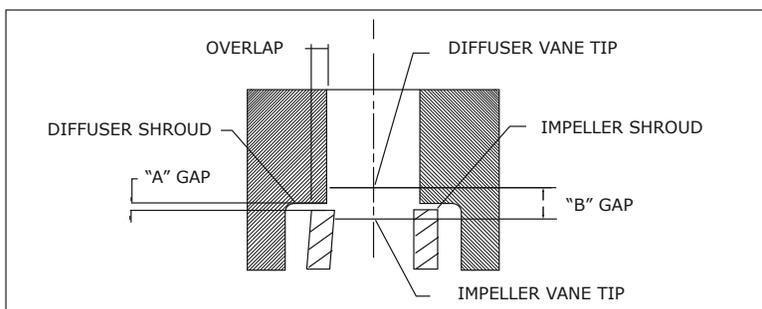
Hydro's Drawing of A Gap, B Gap and Overlap (Image provided courtesy of Hydro Inc.)

Hydro's engineers recommended changing the A gap (between the impeller vane tip and diffuser shroud) and B gap (between the impeller shroud and impeller vane tip) to reduce turbulent flow in the pump, increase rotor stability, and reduce axial shuttling and vibration. The company's team performed rotor centralization, a process they pioneered involving centering the rotating impellers within the stationary diffusers and volutes. Hydro also manufactured new impellers and diffusers using upgraded materials. The impellers were upgraded from bronze to high-grade special stainless steel. The diffusers and return channels were upgraded from cast iron to high-grade special stainless steel.

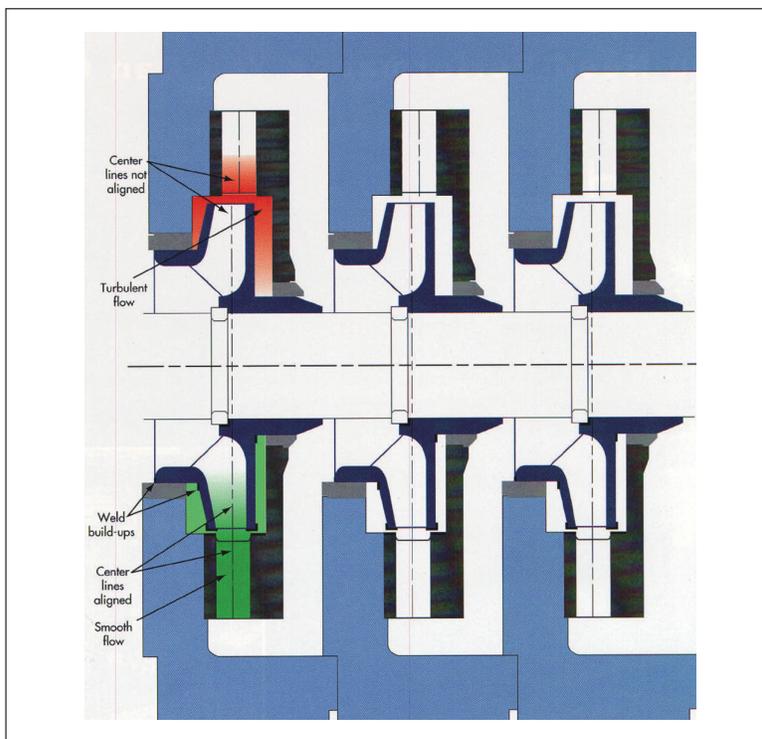
A detailed dimensional inspection is performed by Hydro to establish the centerline relationship of stationary and rotating components. (Image provided courtesy of Hydro Inc.)

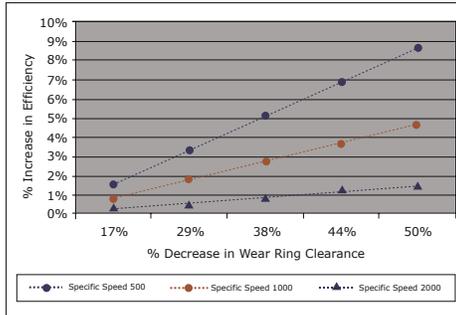
Quantitative results of Hydro's upgrades.
