CASE STUDY: Solving subpar pump performance by finding the right material

A petrochemical manufacturing plant recently faced material-related issues with two fractionator pumps at its performance products plant in Texas. Pump performance was gradually falling off to a point where the pump could not keep up with demand.

By Eric Ford, Vice President, Graphite Metallizing Corporation

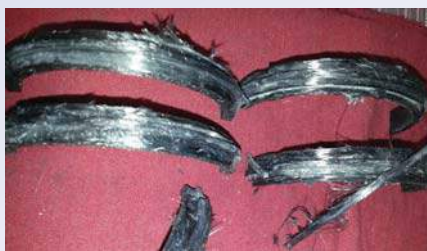
The Area Maintenance Engineer started looking for a longer-lasting option to reduce costs. While the pump was originally supplied with stainless steel bushings and impeller wear rings, these were subject to galling on start-up, and during upset conditions. An upgrade to PEEK material resolved the galling issue, but over time the resin binder started to break down allowing critical clearances to increase and pump performance to drop off. The repair shop suggested switching to a higher, more expensive grade of PEEK. This idea was rejected as there was no guarantee that the new PEEK material would hold up any better as it had not been tested or used in this service before.

Polyetheretherketone bushings and wear rings from the fractionator pumps.

After more research, the decision was made to replace the bushings and wear rings with nickel-filled Graphalloy graphite/metal alloy components, which allow the graphite layers to slide against each other resulting in excellent dry lubrication, is stable

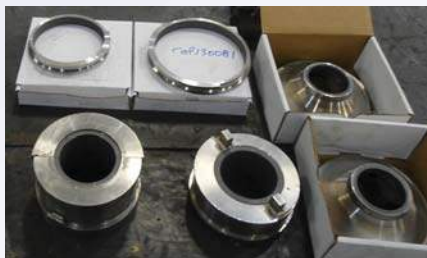
Replacing the old bushings and wear rings allowed the pumps to remain in operation.

The pump internals are 300 series stainless steel. The supplier provided wear rings that were finish machined and installed into the pump's 300 series stainless steel housings. The new material was installed into the eye and hub-side stationary rings, as well as the throat, throttle and center bushings. The first Graphalloy-fitted spare rotor was installed into the pump. The damaged rotor with the PEEK bushings was sent to the shop and fitted with new graphite-based components.

The pump has been through several start/stop cycles and over a year in continuous service without any indication of increasing wear ring clearance or degradation. It has exceeded the runtimes of the previous bushings.
