GRAPHALLOY® | Bearings for Food Industry Applications

DS2529-44

FOOD APPLICATIONS: TOUGH ENVIRONMENTS FOR BEARINGS

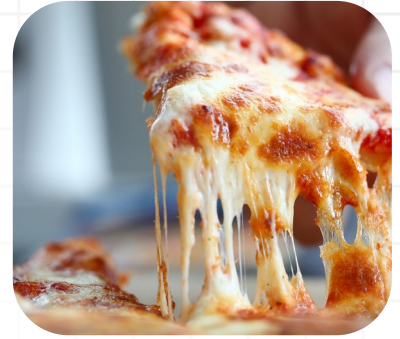
Commercial Pizza Bakery Solves Weekly Failures

The bakery uses two continuous belt-type baking ovens. A typical operating temperature is 525°F. The steel belts in the ovens are 145 feet long, 4 feet wide and travel at 55 FPM. Conventional oil lubricated cam followers only lasted one week in such a high temperature environment. They replaced 16 to 20 burned out cam followers every week for a year. They upgraded to GRAPHALLOY cam followers which went sixteen weeks (and counting) with no sign of wear. Both of their ovens are now equipped with Graphalloy.

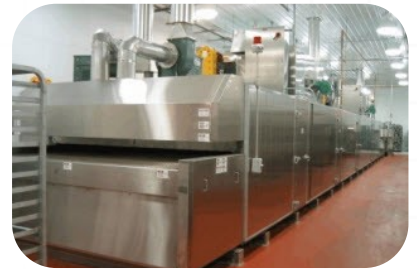
Oven Manufacturer Solves Major Maintenance Problem

A bakery oven OEM was using rolling element bearings on the conveyor circuit of a tunnel oven with a temperature range from 450°F to 650°F. To reach these bearings, mechanics would have to crawl over the oven belt when the machine was shut down, thus causing damage and presenting a safety risk. Another issue was caustic washdowns that rusted the ball bearings. In some applications, bearing life was as little as 2 weeks. They were researching solutions when they discovered GRAPHALLOY. Now, Graphalloy bushings in stainless steel pillow block housings have been running in this application for several years with no issues.

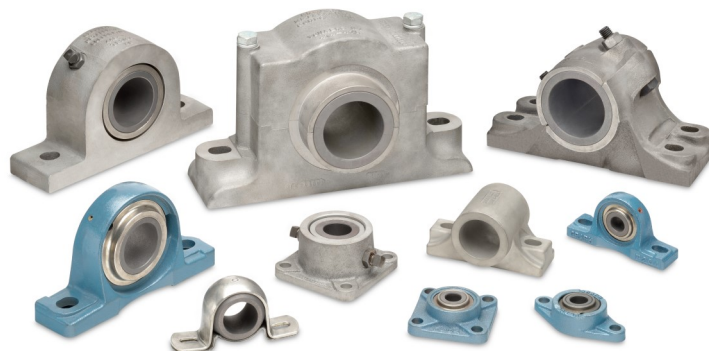
Seafood Freezer Conveyor Extends Bearing Life by 30x

A seafood processing plant in the Southeast was running a conveyor in their freezer area to "flash-freeze" fresh seafood. The environment is a difficult one: it is cold (28°F/-2°C) and wet and the system requires frequent washdown. The conveyor bearings were being replaced every month. The plant maintenance superintendent contacted GRAPHALLOY about the problem. It was determined that the current bearings could not hold lubrication under these conditions and, as a result, breakdowns were occurring frequently. Graphalloy 4-bolt flange block assemblies were installed and have been running successfully for more than five years!
