GRAPHALLOY® Pillow Blocks: 20 Years of Service in a Submerged Environment

Reliable in Wastewater Treatment

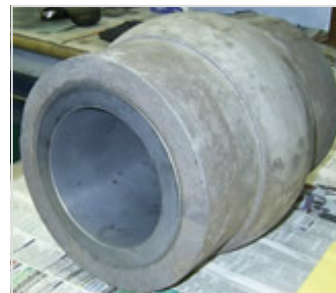
Using the imprint code from the outside of the casting, Graphite Metallizing was able to identify the pillow blocks used in the unit. The maintenance manager at the condominium complex removed two of the pillow blocks and drove the insert assemblies to the Graphite Metallizing manufacturing facility in Yonkers. Once the units were disassembled, the original bushings proved to still be functional after 20+ years of operation in the abrasive conditions. The old bushings were removed and new GRAPHALLOY bushings were manufactured and installed in the housing.
