Block Bearings in Tortilla Oven, Belgium

Snack Food Producer, Belgium- Tex Mex Food

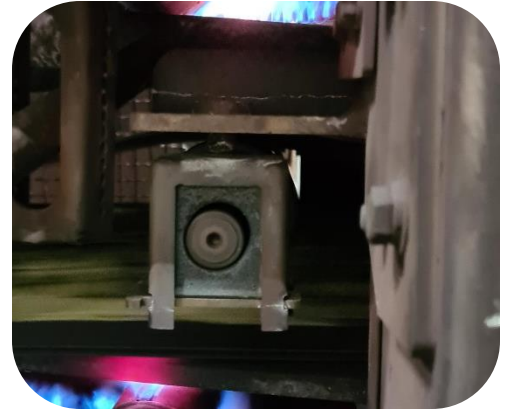
High Speed Tortilla Chip Oven, originally manufactured by Lawrence Equipment in the US. The oven is equipped with 3 conveyor belts running at a speed of 83-93 m/min and a temperature of 400-500°C. The shafts supporting these conveyor belts are equipped with graphite block bushings which are installed outside the firebox.

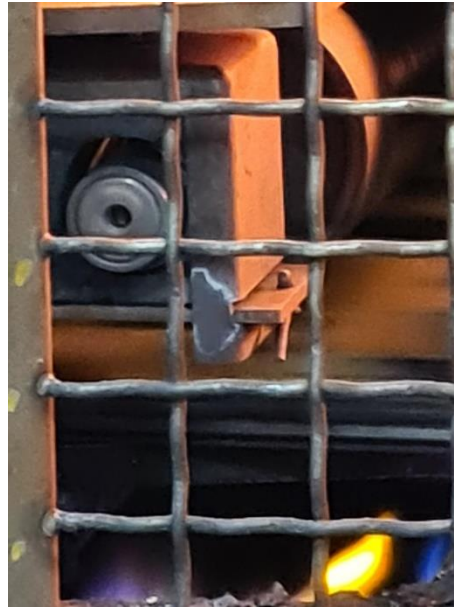
The graphite block bushings supplied by the oven OEM have a high failure rate. The original supplier of these bushings is unknown. A total of 42 bushings are installed in the oven and every week 10-15 pieces need to be placed. The bushing material appears to be brittle when removed.

Original Bearing in Application

After a thorough investigation, Graphalloy's Engineering team found that the current housing is too big for standard block bushings and therefore not able to maintain the correct tolerance during operating conditions. A custom block bushing that will fit the existing housing with the right tolerance was offered. To withstand the extreme conditions, Graphalloy copper-grade material was selected which can up to 400°C.

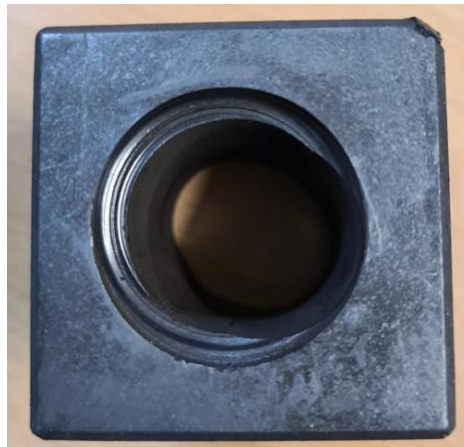
Wear of Original Plain Graphite Bearing

By providing custom block bushings of the right material the failure rate has been reduced to a maximum of 2 pieces per week. This is a significant improvement resulting in less downtime and higher productivity.
